**Flood Control Project Maintenance
Levee Inspections**

Maintenance Issue Types Only, Levee Inspection Report By Mile - Spring 2016

California Department of Fish and Game Shea Levee

Waterway	Bank	Unit Miles	Inspection Start/End	Inspector
Unit No. 01 Sacramento River	Left	0.30	04/27/2016 04/27/2016	Keith Millard

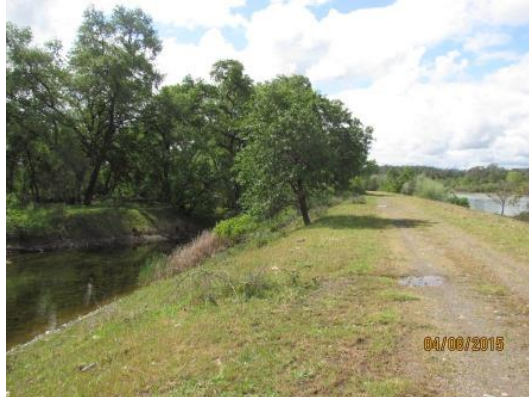
Photo 1 of 2 : SP_2016_NA0018_269_2_20160316_00003.jpg

LM Start	0.00	Rating **	M	Issue No.	2
LM End	0.07	Issue Type +	Ma	Location *	LS
Category	Earthen Levee			GPS Latitude/Longitude	
				Start	End
Item	Vegetation			40.508138 °	40.508138 °
				-122.363480 °	-122.363480 °
DWR ID	DWR_NA0018_01_s_2012_2				
Comment Code					
V2 : Remove the wild growth other than native grasses from the levee slopes.					
Inspector Comment					
California Department of Fish and Wildlife has not completed any maintenance this year.

View of the levee with no maintenance done.

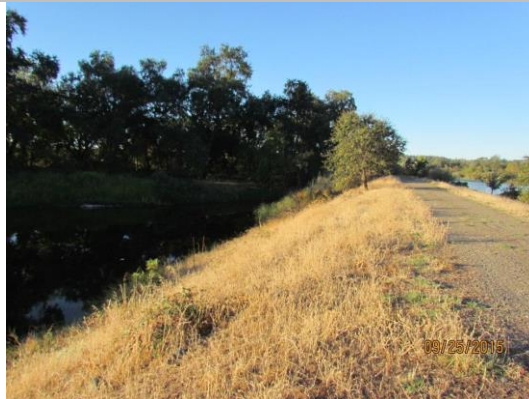
Photo 2 of 2 : SP_2016_NA0018_269_2_20160316_00004.jpg

View of the levee with no maintenance done.

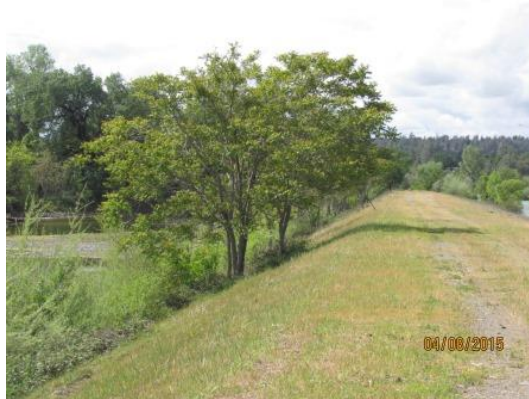
Photo 1 of 2 : SP_2016_NA0018_269_9_20160316_00009.jpg

LM Start	0.00	Rating **	M	Issue No.	9
LM End	0.21	Issue Type +	Ma	Location *	LS
Category	Earthen Levee			GPS Latitude/Longitude	
				Start	End
Item	Trim / Thin Trees			40.509012 °	40.510649 °
				-122.362609 °	-122.360945 °
DWR ID	DWR_NA0018_01_f_2012_9				
Comment Code					
T2 : Thin trees to allow visibility of the ground and room to flood fight.					
Inspector Comment					
Fish and Wildlife Service has not completed any maintenance.

Remove the small trees along the landside slope.

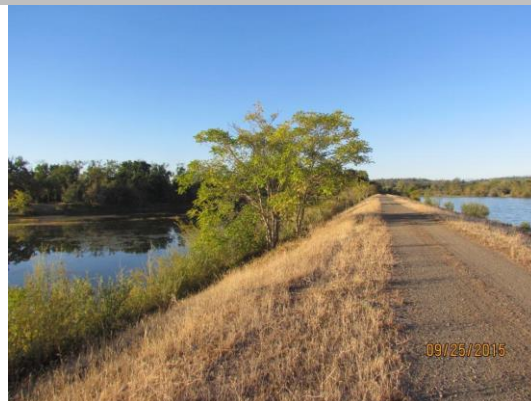
Photo 2 of 2 : SP_2016_NA0018_269_9_20160316_00010.jpg

LM Start	0.00	Rating **	M	Issue No.	9 (cont)	
LM End	0.21	Issue Type +	Ma	Location *	LS	
Category	Earthen Levee			GPS Latitude/Longitude		
				Start		End
Item	Trim / Thin Trees			40.509012 °		40.510649 °
				-122.362609 °		-122.360945 °
DWR ID	DWR_NA0018_01_f_2012_9					
Comment Code						
T2 : Thin trees to allow visibility of the ground and room to flood fight.						
Inspector Comment						
Fish and Wildlife Service has not completed any maintenance.

Remove the small trees along the landside slope.

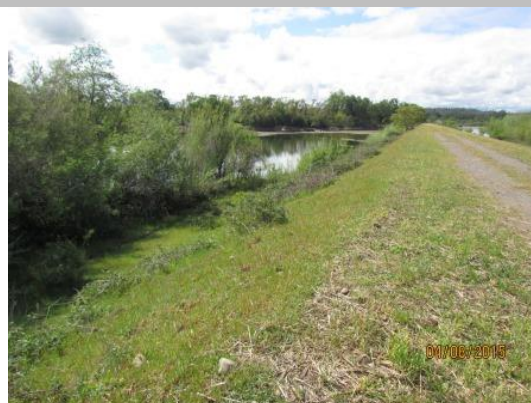
Photo 1 of 3 : SP_2016_NA0018_269_1_20160316_00001.jpg

LM Start	0.10	Rating **	M	Issue No.	1
LM End	0.30	Issue Type +	Ma	Location *	LS
Category	Earthen Levee			GPS Latitude/Longitude	
				Start	End
Item	Vegetation			40.511185 °	40.510670 °
				-122.360553 °	-122.361203 °
DWR ID	DWR_NA0018_01_s_2012_1				
Comment Code					
V2 : Remove the wild growth other than native grasses from the levee slopes.					
Inspector Comment					
Fish and Wildlife Service has not completed any maintenance.

View of the blackberries and other vegetation along the landside slope.

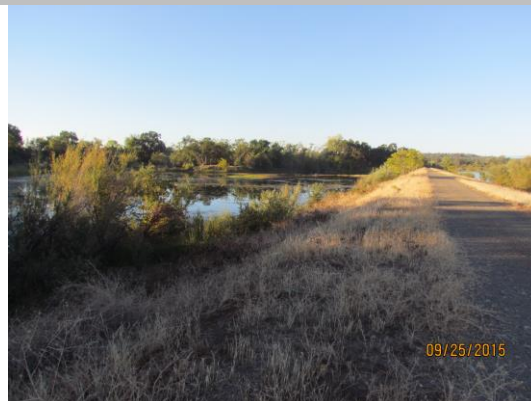
Photo 2 of 3 : SP_2016_NA0018_269_1_20160316_00002.jpg

View of the blackberries and other vegetation along the landside slope.

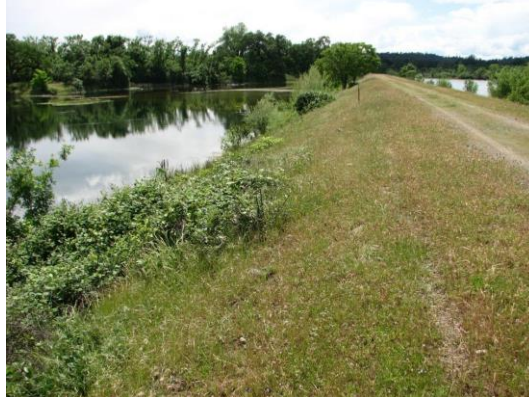
Photo 3 of 3 : SP_2016_NA0018_269_1_20160506_00011.jpg

LM Start	0.10	Rating **	M	Issue No.	1 (cont)	
LM End	0.30	Issue Type +	Ma	Location *	LS	
Category	Earthen Levee			GPS Latitude/Longitude		
				Start		End
Item	Vegetation			40.511185 °		40.510670 °
				-122.360553 °		-122.361203 °
DWR ID	DWR_NA0018_01_s_2012_1					
Comment Code						
V2 : Remove the wild growth other than native grasses from the levee slopes.						
Inspector Comment						
Fish and Wildlife Service has not completed any maintenance.

04/27/2016: View of the blackberries and other vegetation along the landside slope.

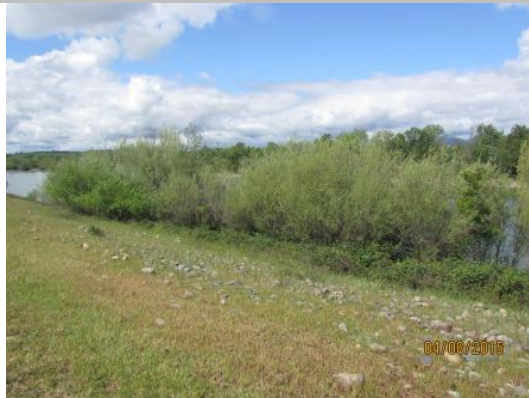
Photo 1 of 2 : SP_2016_NA0018_269_4_20160316_00005.jpg

LM Start	0.21	Rating **	M	Issue No.	4
LM End	0.26	Issue Type +	Ma	Location *	WS
Category	Earthen Levee			GPS Latitude/Longitude	
				Start	End
Item	Trim / Thin Trees			40.511518 °	40.508234 °
				-122.360100 °	-122.363430 °
DWR ID	DWR_NA0018_01_s_2012_4				
Comment Code					
T3 : Trim and thin trees to allow visibility of the ground and room to flood fight.					
Inspector Comment					
Trim the trees along the waterside slope.

Trim the trees along the waterside slope.

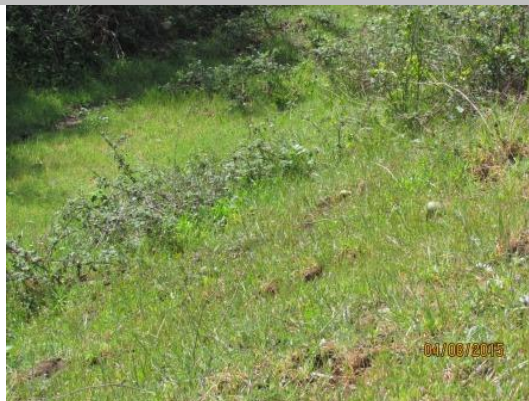
Photo 1 of 2 : SP_2016_NA0018_269_6_20160316_00007.jpg

LM Start	0.22	Rating **	M	Issue No.	6
LM End	0.30	Issue Type +	Ma	Location *	LS
Category	Earthen Levee			GPS Latitude/Longitude	
				Start	End
Item	Animal Control			40.510671 °	40.511185 °
				122.360944 °	122.360553 °
DWR ID	DWR_NA0018_01_s _ 2013_6				
Comment Code					
A2 : Repair the levee slope damaged by livestock and prevent large animal access.					
Inspector Comment					
The livestock damaged the L/S slope.

View of the livestock erosion along the landside slope.

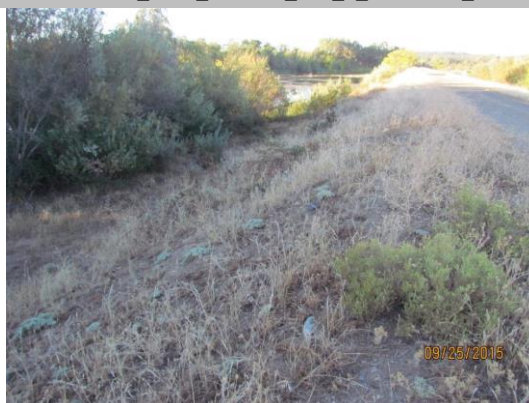
Photo 2 of 2 : SP_2016_NA0018_269_6_20160316_00008.jpg

View of the livestock erosion along the landside slope.
